Attachment 8 to Report 06.441

# Wairarapa Peer Review 2005/06

August 2006

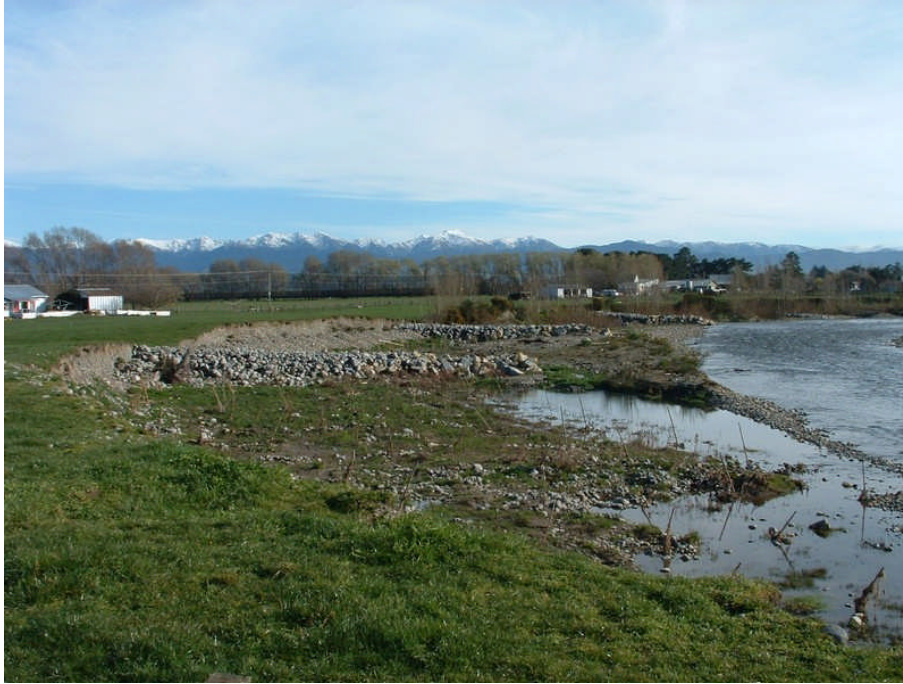
Photo 1: Boulder groynes adjacent to Daniel's property

*The reviewers' noted damage to willow poles from a recent flood event and from stock. The reviewers' recommend the addition of netlon sleeves to the willow poles to reduce the degree of debarking during a flood event and also recommend that the landowner is requested to fence the works off from stock. The area should be interplanted to replace the damaged willow poles once the fencing is complete.*

*A constriction exists at the downstream end of the works and the reviewers' support the proposed willow removal planned for this financial year.*

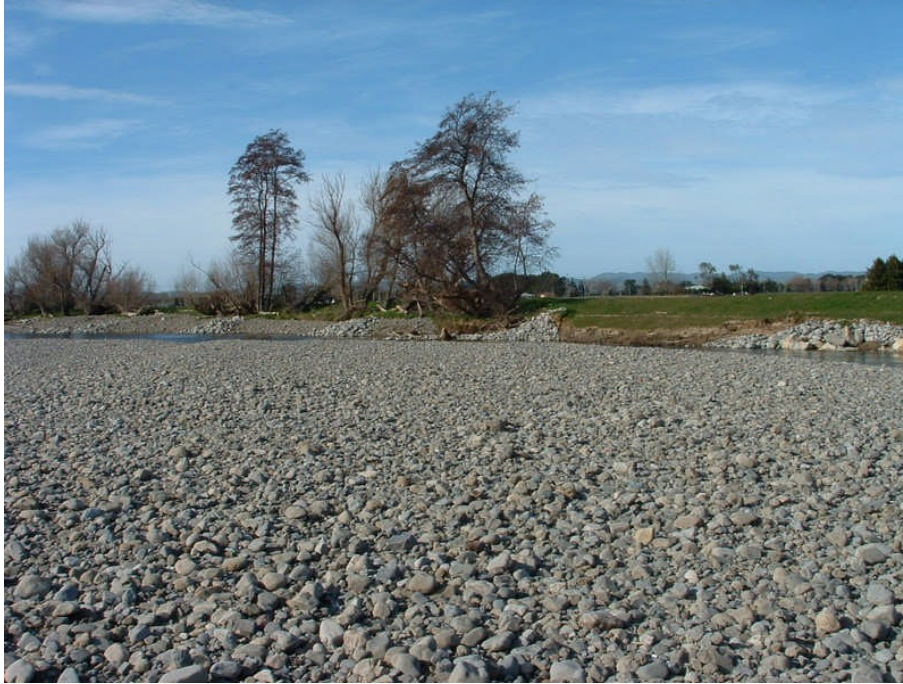
Photo 2: Boulder and gravel groynes. Note lateral bank edge erosion & large gravel beach.

*Overall the reviewers' agree with the works constructed to hold the river in the desired alignment, and note that the works had passed recent flood events with little or no damage.*

*Two points of concern were noted:*

- *Lateral erosion downstream of the rockline is occurring, and the reviewers' recommend that some small snub groynes are constructed to flick the river out from the bank edge.*
- *A large gravel beach has built up on the inside of the bend and the reviewers' recommend that this beach is extracted to ease the pressure to the left bank.*

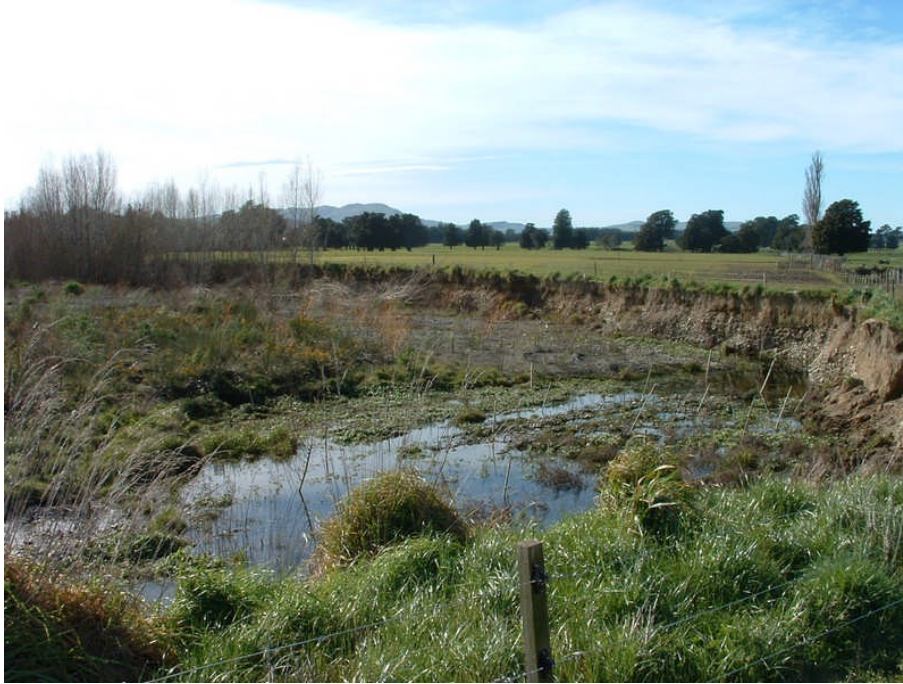
Photo 3: Lateral erosion at Buick property, newly planted willow poles.

*The reviewers' note that the hay barn pole and wire debris fences, used as an alternative to the traditional rail iron and wire debris fences due to financial constraints, are performing well. The willows are successfully established.*

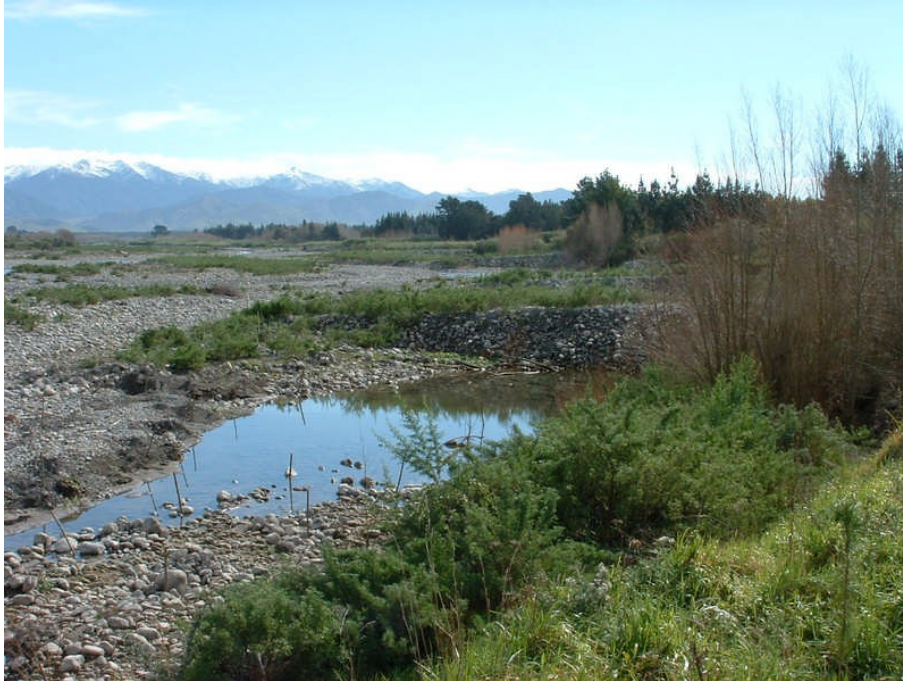
Photo 4: Shingle groynes & willow plantings.

*The reviewers agree with the approach taken in this situation and believe that the shingle groynes will provide adequate bank edge protection to allow the establishment of a well vegetated buffer zone. The reviewers' note that future interplanting of willow poles will be required.*

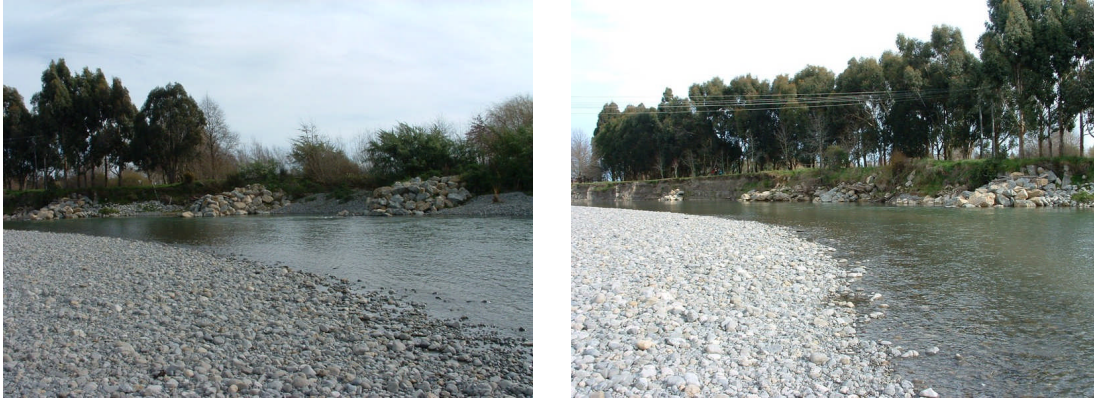
Photo 5: Looking upstream and downstream at boulder and shingle groynes.

*With the works only constructed in March of this year they are still very vulnerable, and will continue to be, until the area is stabilised through plantings. A large gravel beach has built up on the inside of the bend and the reviewers' recommend that this beach is extracted to ease the pressure on the newly constructed works.*

*The existing groynes, which were recently topped up, were in good condition but the newly constructed groynes require some attention. There is erosion evident between the groynes and the groynes themselves show signs of slumping. The reviewers' recommend that the size and spacing of these groynes is investigated.*

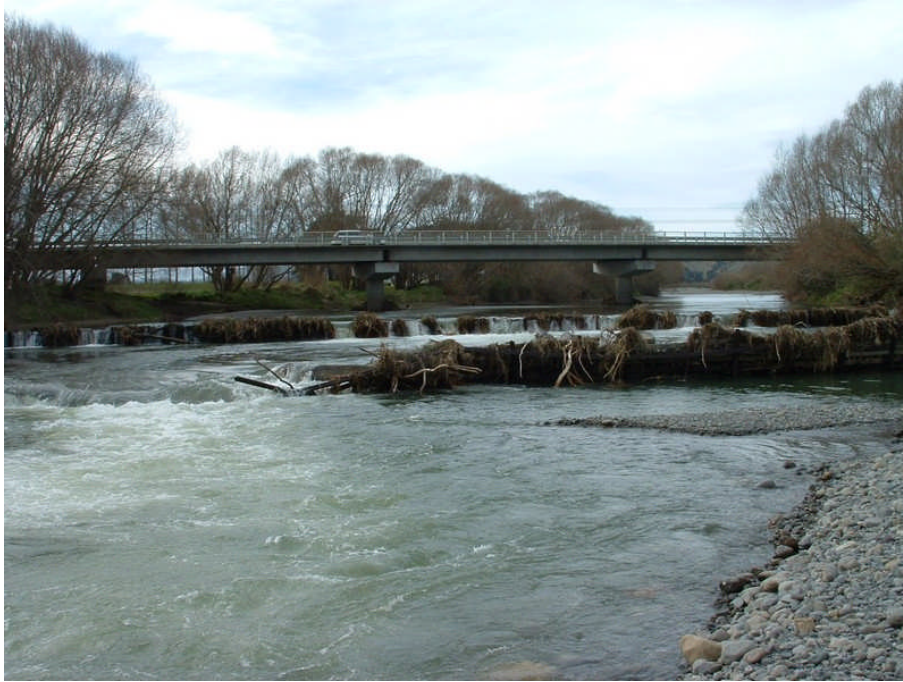
The reviewers were shown the failing Te Ore Ore grade control weir in the hopes that some solutions may be offered. The timber and iron grade control weir was constructed a number of years ago to protect the former road bridge, which was being undermined; this bridge has since been replaced and the current road bridge is not at risk from degradation.

The weir has been progressively failing over a number of years but has not been removed for two reasons:

1. Gravel is commercially extracted upstream of the weir.
2. Approximately 1 km upstream of the weir, is the intake for the Henley Lakes; this intake is vulnerable to fluctuations in riverbed levels.

Photo 6: The failed Te Ore Ore grade control weir.

*The reviewers' could not offer a solution but asked a number of questions:*

- *Is the weir actually required?*
- *Could the weir be repaired in-situ?*
- *If the weir was removed, what impact would this have on the river overall?*

*The reviewers' recommend a study of this reach is commissioned to provide answers to the above questions.*

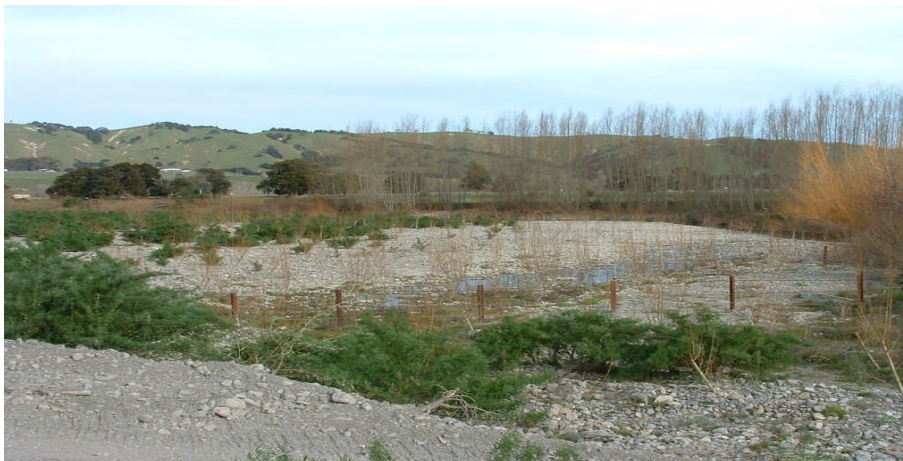
At this location, the Ruamahanga River is immediately adjacent to Masterton District Council's sewage treatment plant, in particular the oxidation ponds. In 2000, the right bank edge was severely eroded and a stopbank lost. The stopbank has since been relocated but the bank edge was eroded again in the February 2004 flood event. To repair the erosion and rebuild the right berm, gravel was moved from the left to the right bank, rail and pole debris fences were constructed, and the area mass planted with willow poles.

Photo 7: Reconstructed with debris fences and willow plantings

*The reviewers' recommend that:*

- *The channel alignment is monitored.*
- *The left bank erosion upstream of the works at the change over point is investigated.*
- *That the gravel beach downstream of the works is investigated.*
