# Wairarapa Coastal Habitats

Mapping, Risk Assessment and Monitoring

Prepared  
for  
**Greater  
Wellington  
Regional  
Council**

**January  
2007**

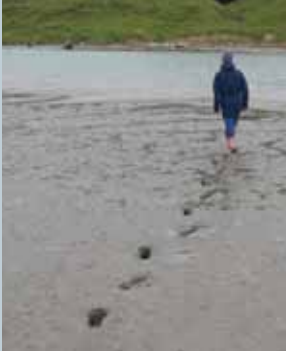
### TIDAL RIVER ESTUARIES

One of the Wairarapa estuaries fits into the “tidal river estuary” category (i.e. Whareama Estuary). They are characterised by an elongated shallow basin, with river-dominated (rather than tide-dominated) circulation. Flushing is good because the mouth is always open and river flow relatively large. Tidal flats are present but not broad and expansive. Salinity is generally much less than the sea and waters can be fresh during floods (Kirk and Lauder 2000). Such estuaries can be quite productive and have good fisheries but the absence of large areas of salt marsh limits their ecological value, particularly for birdlife.

The Whareama River is large enough to keep the sand or gravel barrier at the mouth permanently open. In addition, it is a very low slope on the tidal plain which allows for much greater tidal intrusion (tidal waters extend up to 12 km inland in the Whareama Estuary), and larger parts of the lower estuary become tidal mudflats at low water. This estuary, with its more regular patterns of tidal inundation and presence of mudflats, favours greater biodiversity than riverine lagoon estuaries and is less prone to degradation of water and sediment quality. Sediment in the Whareama ranges from fine to coarse sands/gravels in the barrier and tidal inlet deposits, fine organic muds and sandy muds in the central basin, to coarse, unsorted gravels, sands and muds (mostly of terrigenous origin) in the fluvial bayhead delta.

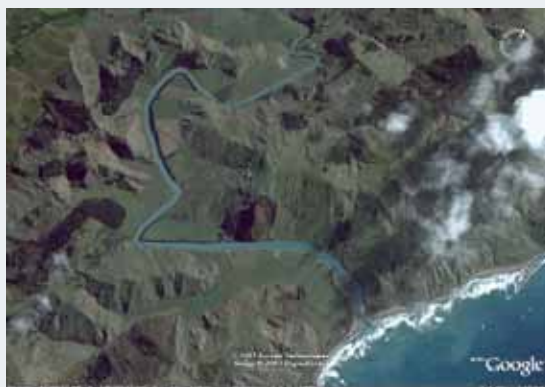
River flow is typically high, and flooding may expel marine water and flush material from the estuary. Turbidity, in terms of suspended sediment, is naturally elevated given the soft rock type catchment. The central basin is generally an efficient ‘trap’ for terrigenous sediment and pollutants, except in shallow estuaries.

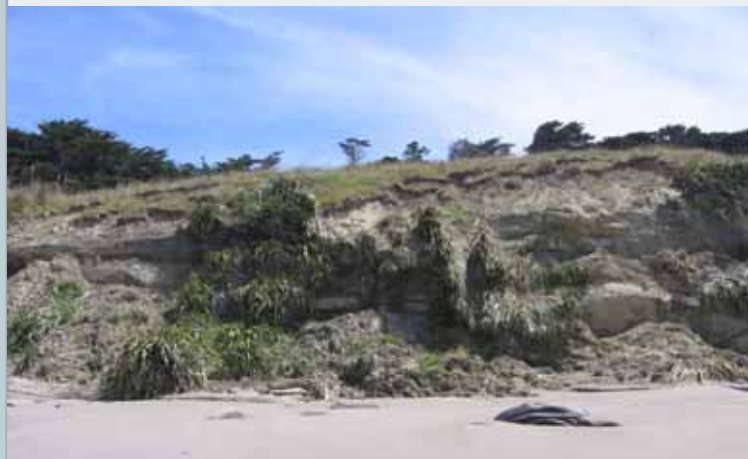
Only small streams discharge to this section of the coast except for the Whareama River which drains an extensive and very erosion-prone catchment with a high suspended sediment yield. As a consequence, sediment loads are elevated and turbid waters often bathe this section of the coast.

Erosion near Otahome

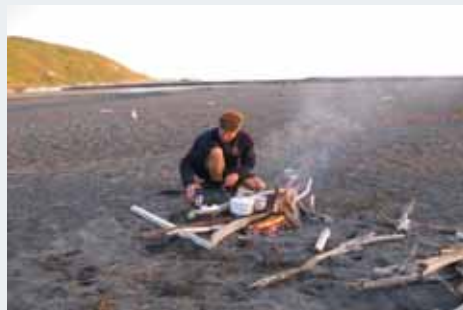
A number of streams and rivers discharge to this section of the coast. All drain predominantly hard rock catchments and consequently they tend to have low sediment loadings. All are river mouth lagoon type estuaries and experience various levels of mouth constriction depending on swell size, direction and river flows. Given that the catchments are generally bush-clad or extensively grazed grassland, nutrient and pathogen loadings are expected to be low. Consequently, although the estuaries may block at times, their water quality is not expected to degrade to low levels.

Clear inshore waters. Hard rock and gravel shores and reefs. Steep beaches. Dunes absent. Towering greywacke cliffs fringed by uplifted platform used for grazing stock. Very narrow surf zone. Hard rock catchments. Very exposed.
