Porirua Harbour

Broad Scale Habitat Mapping 2007/08

Prepared
for
Greater
Wellington
Regional
Council and
Porirua City
Council
June
2008

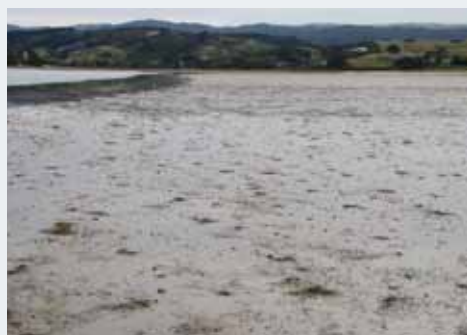
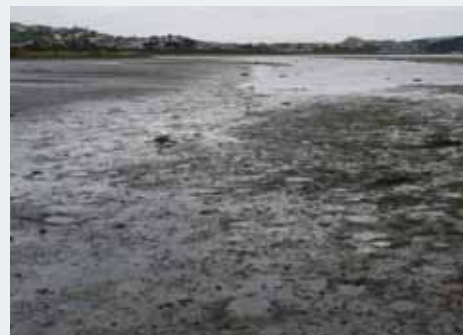
Firm mud/sand flats in the Pauatahanui Arm (left) and Porirua Arm (right).

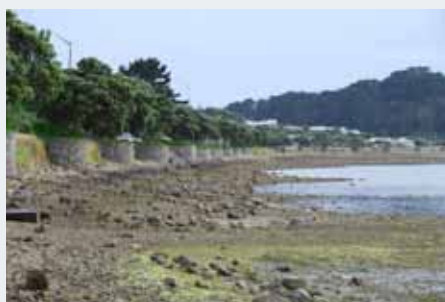
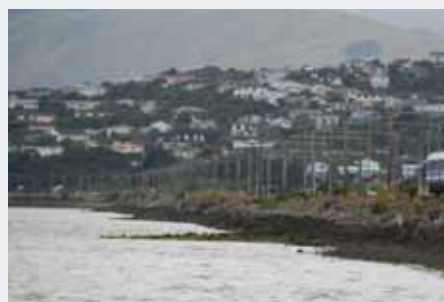
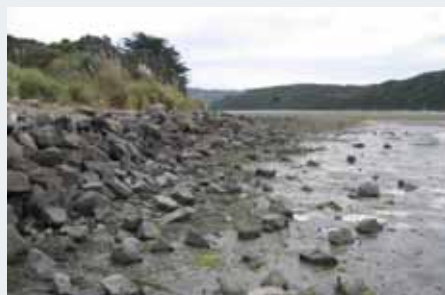
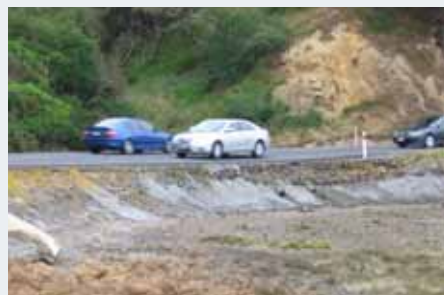
The steep slopes, along with associated increases in wave energy and tidal inundation, combine to create conditions generally unfavourable for the natural re-establishment of saltmarsh. Further, the seawalls greatly reduce the capacity for the estuary to respond to changes in sediment and water levels likely to result from predicted sea level rise, one of the major stressors identified in the recent vulnerability assessment of the estuary (see Robertson and Stevens 2007b).

Seawalls also reduce the diversity of available habitat for key ecological uses such as bird feeding and roosting and whitebait spawning, and create a physical barrier discouraging human access to the estuary.

Examples of artificial seawalls along the estuary margin.

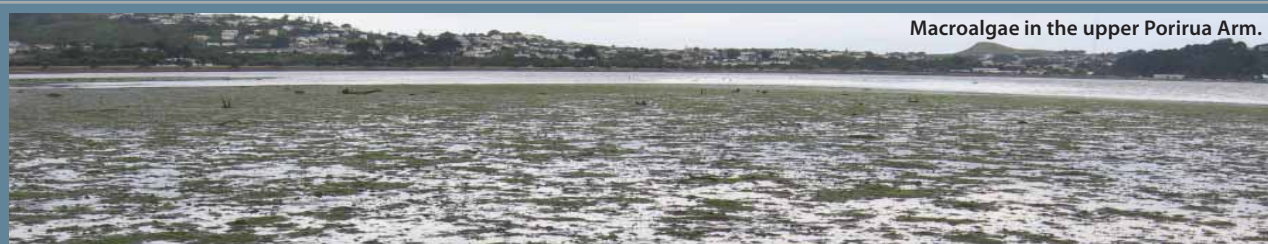
Macroalgae in the upper Porirua Arm.

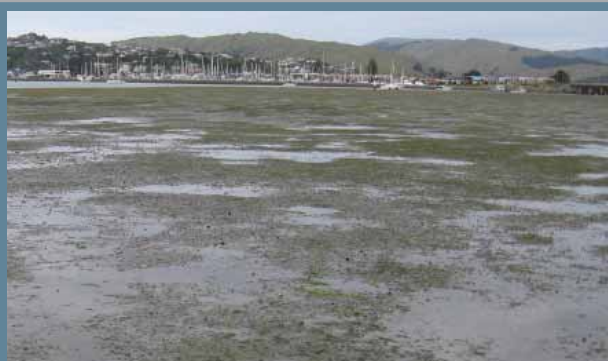
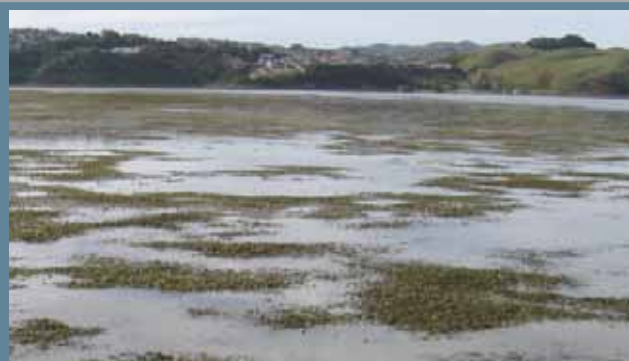
The largest beds were located on the well flushed tidal flats in the lower (seaward) part of each arm (Figure 4 and photos below), with plants appearing lush and healthy. Macroalgal growths were commonly present growing on and within the seagrass beds.

Examples of extensive *Zostera* beds in the Porirua Arm (left) and the Pauatahanui Arm (right).

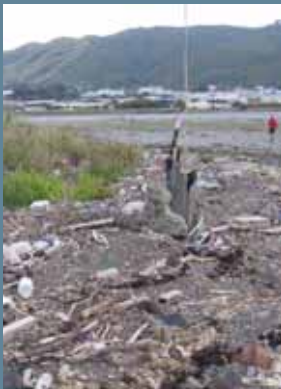
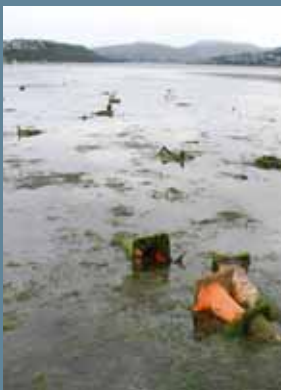
Another feature noted was the large amount of litter in the upper Porirua Arm of the estuary. Much of the litter (see photos left) consisted of relatively small items including plastic bottles and bags, tyres and road marking cones that are relatively easy to remove.
