South Wairarapa District Council Resource Consent Application and Assessment of Effects on the Environment, Coastal Protection Works

Prepared for South Wairarapa District Council (Client)

By Beca Carter Hollings & Ferner Ltd (Beca)

24 April 2009

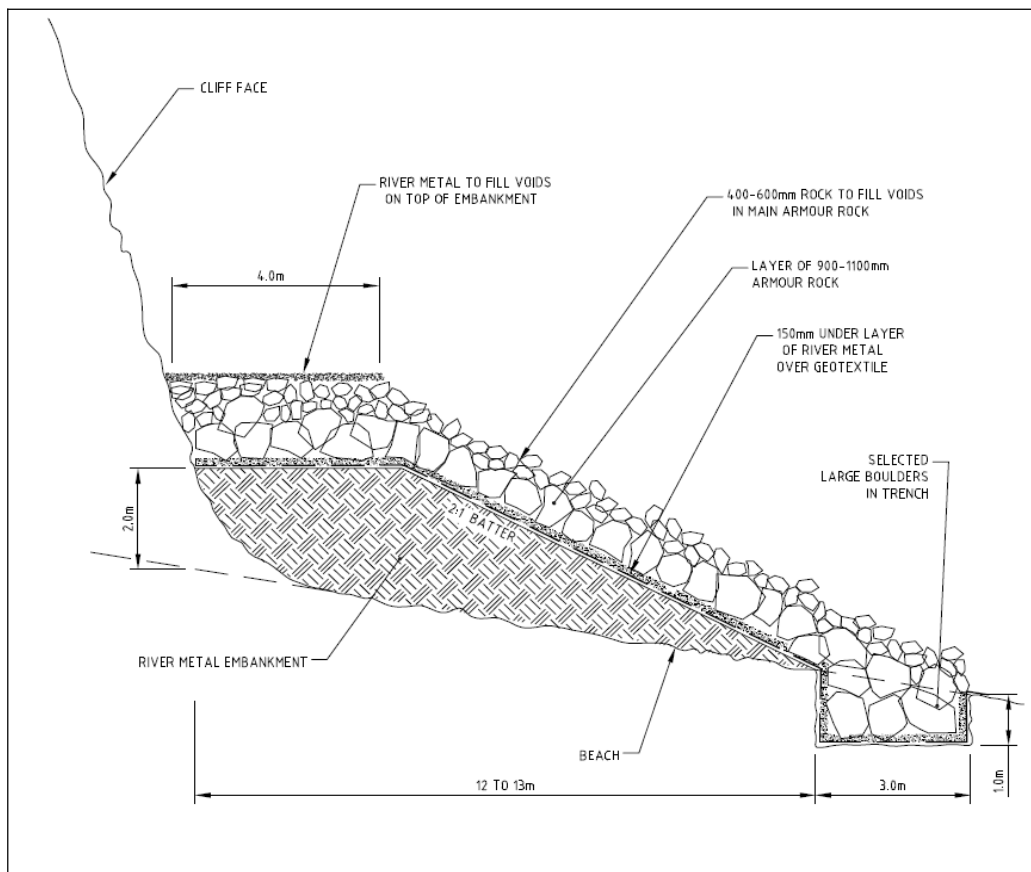
- A boulder beach to protect cliff areas (refer Figure 1)

The construction of the three boulder beach arrangements involve preliminary site earthworks to establish a working profile and backwall support, and the placing of river metal from the seaward footing to the cliff, road or gabion wall edge. This foundation will be overlaid by a heavy-duty geotextile fabric, which will extend from the seaward footing to the cliff face.

The boulder beach will be recessed at the seaward margin with the toe trenched at least 1 metre into the underlying beach to prevent failure of the structure through undermining. The rock protection will be placed at a slope of 2H to 1 V so the total height above sea level will build to approximately 1 to 3m in height depending on the nature of the affected coast line (i.e. height of adjacent land to be protected). The slope of the face of the boulder beach structure (2:1) is such that access to the coast by able bodied persons is not prevented. Additionally as the boulder beaches are not continuous along the coastline, then access to the coast is feasible through unprotected parts of the shoreline. Access points will however be designed for boulder beaches that extend longer than 500 metres (the design of these access points is attached as Appendix I).

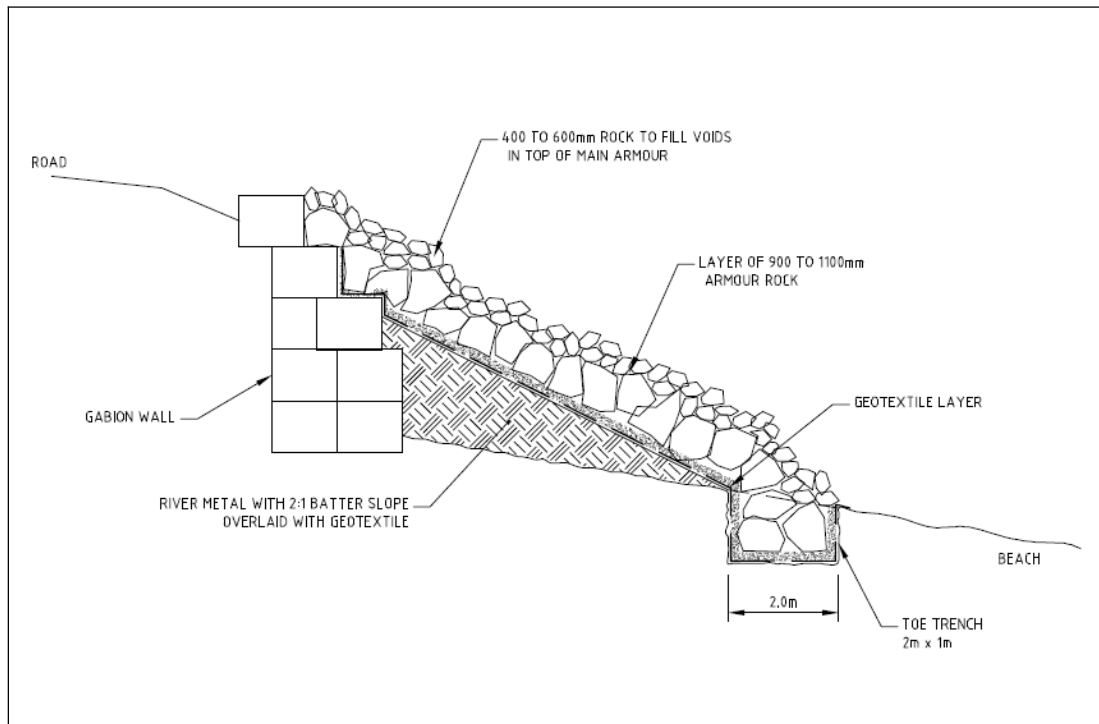
- A boulder beach to protect Gabion Walls (refer Figure 2)

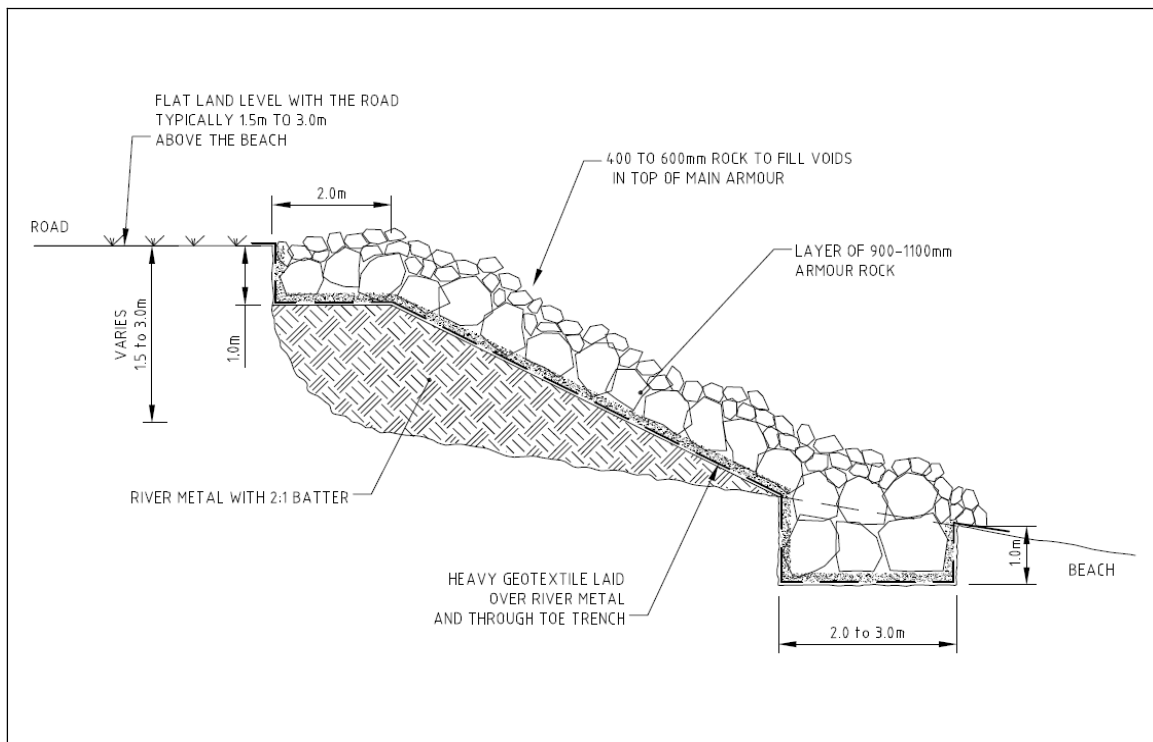
- A boulder beach to protect the road edge close to the beach (refer Figure 3)

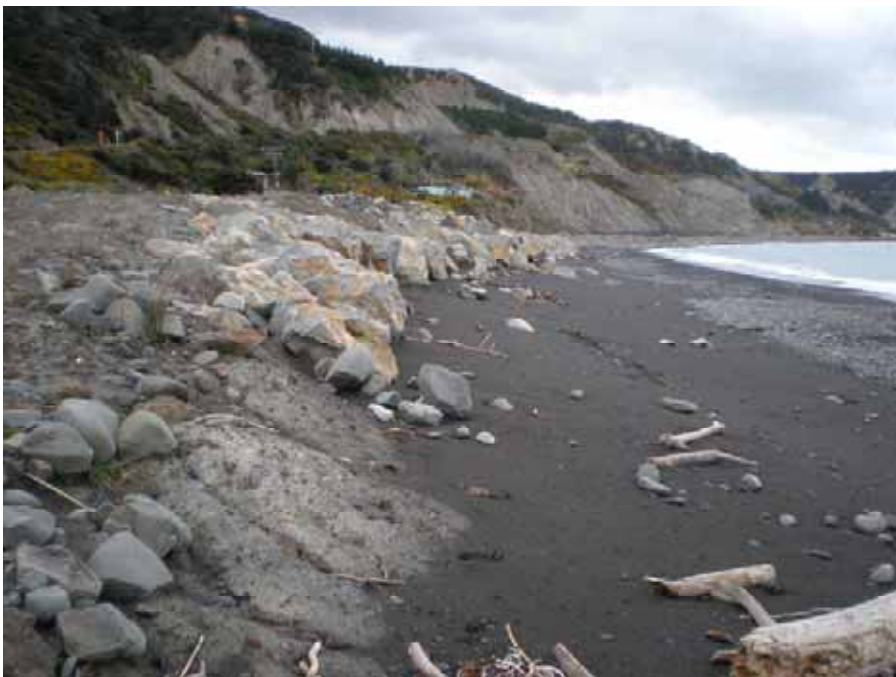
Figure 1: Photograph showing rocky beach material, an existing boulder beach and cliffs along the coastline

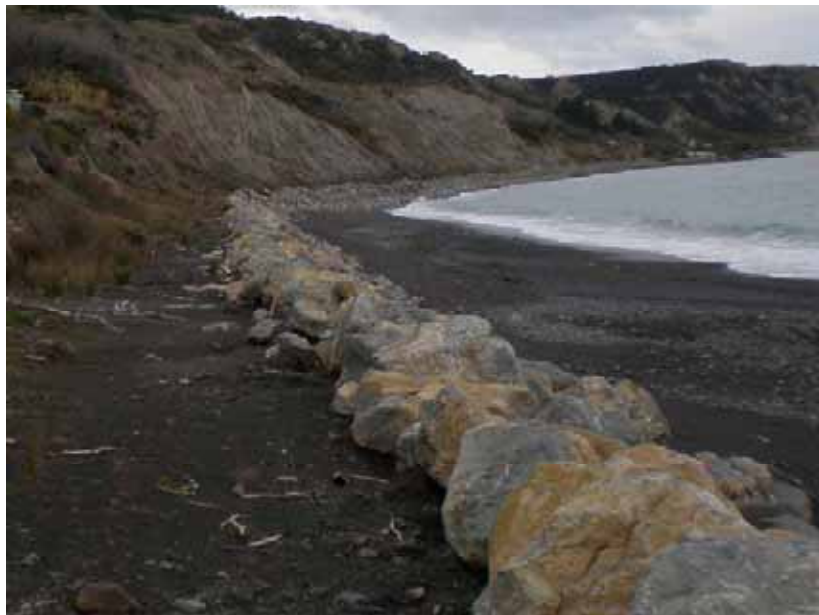
Figure 2: Photograph showing existing boulder beach material

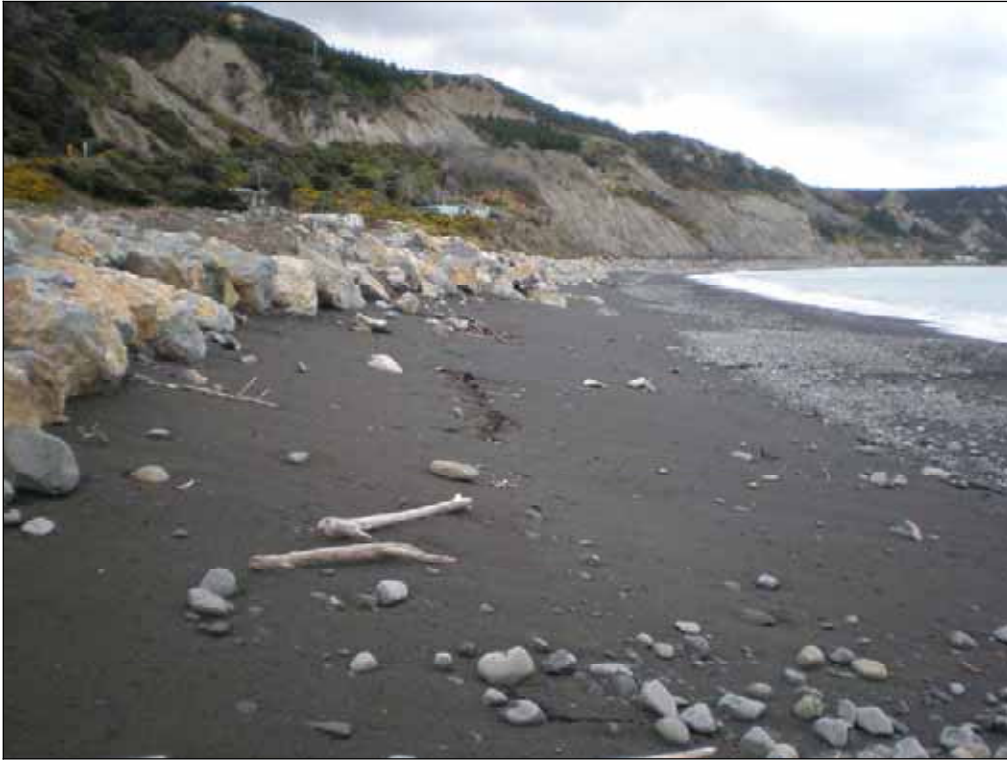
Figure 1: Existing Boulder Beach

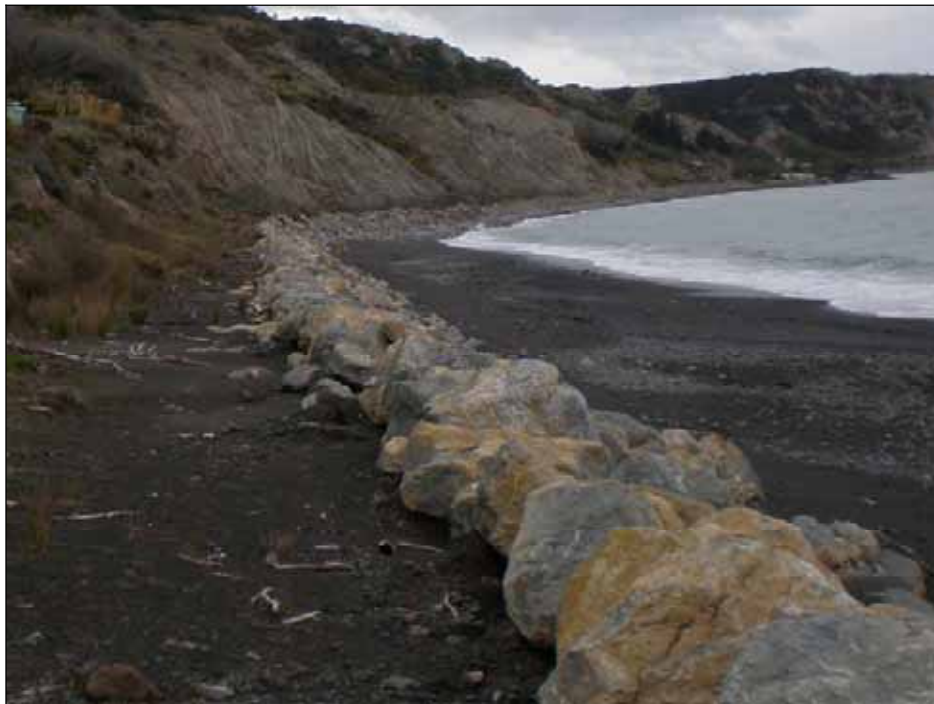
Figure 2: Existing Boulder Beach

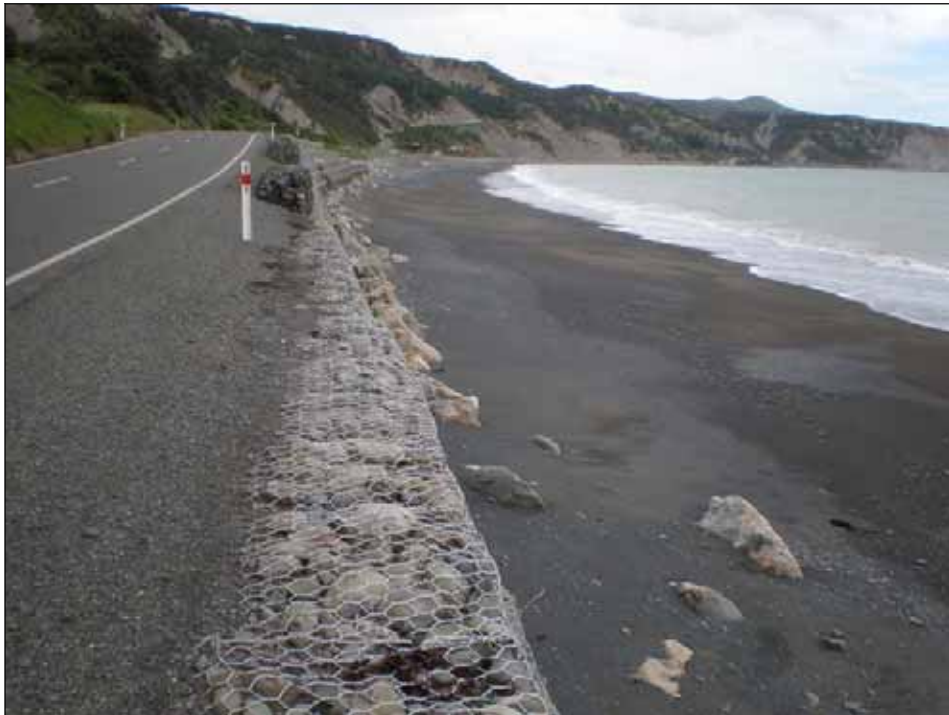
Figure 4: Existing Gabion Wall

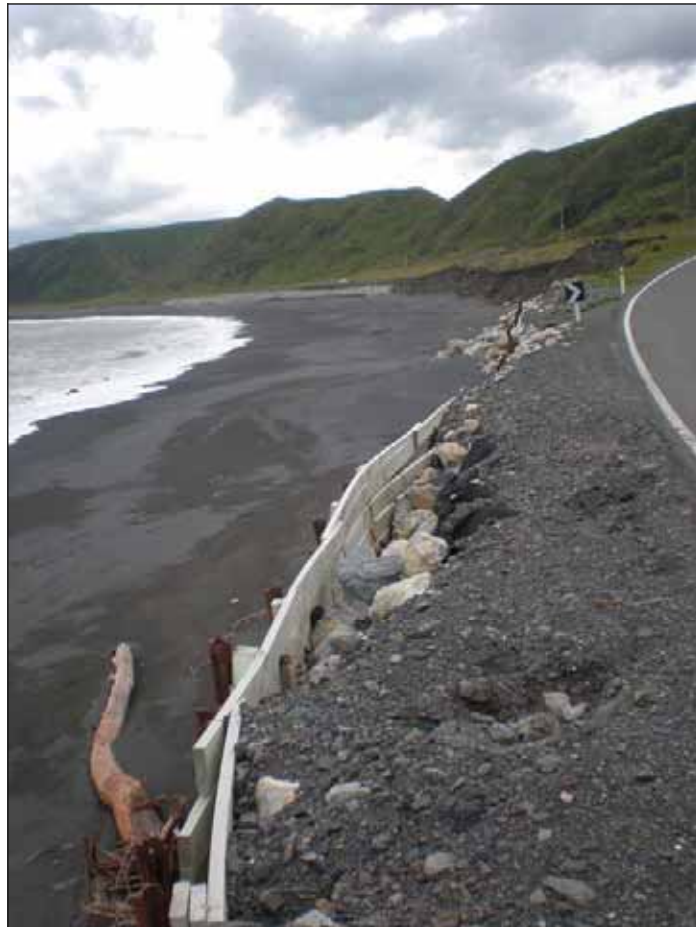
Figure 6: Existing Timber Protection Fence

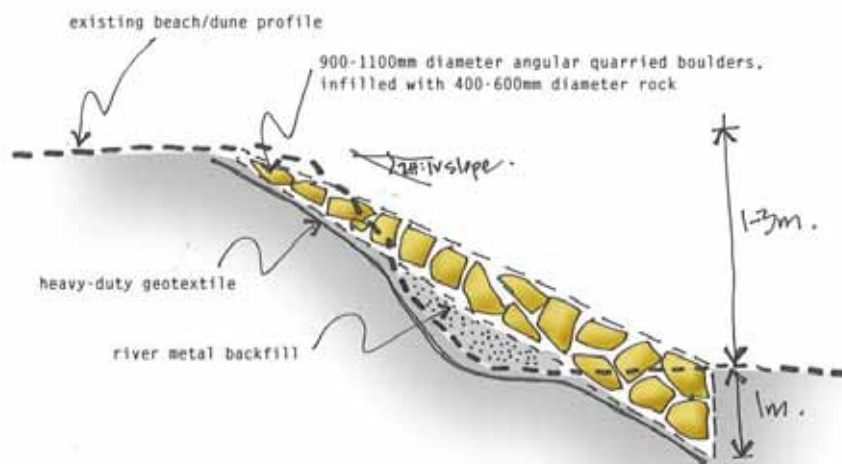
A typical section of the proposed 'boulder beach' construction is shown in Figure 1. The design has been prepared by SWDC, and is the same as other protection works already constructed along the coastline (existing boulder beaches are mapped on Maps 1-10 in Appendix A of Beca's AEE). These have been monitored since installation, and are reported to provide effective prevention.

Figure 1: Indicative section of proposed boulder beach (from description in AEE)

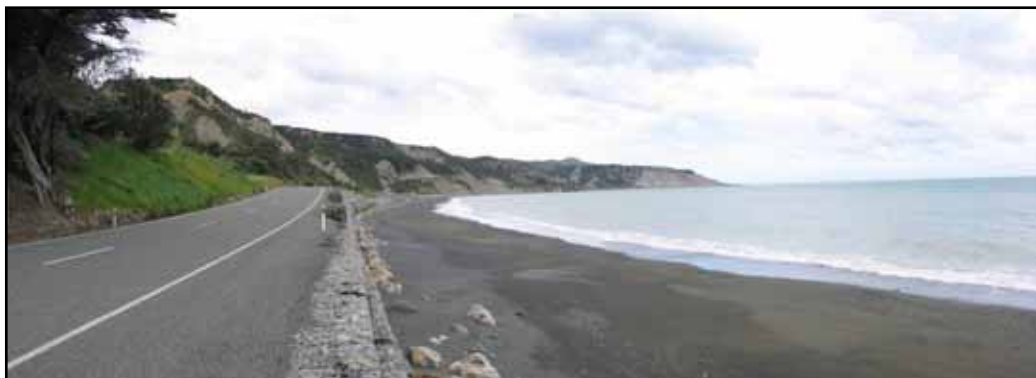
Figure 2: Existing section of sea wall (gabion baskets) south of Te Kopi

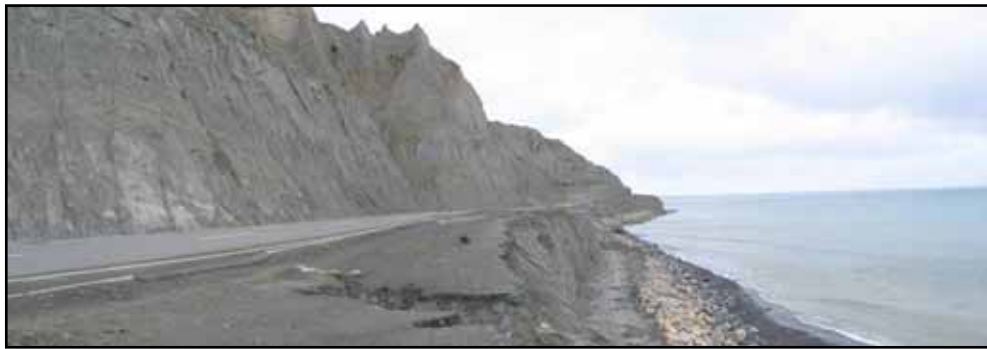
Cape Palliser Road itself and its associated curtilage (drainage, electricity, slope protection and contouring) has also influenced the character of the landscape, particularly around Whatarangi, where the coastal terrace is at its most narrow, and erosion has caused the road to be realigned landward on several occasions. Each time this has occurred, a more invasive series of terraces and benches has been created to achieve the road platform – to the point where the entire headland around the Whatarangi Bluff now appears ‘engineered’ (refer figure 3).

Figure 3: View south towards Whatarangi Bluff, showing extent of terracing required to achieve road platform

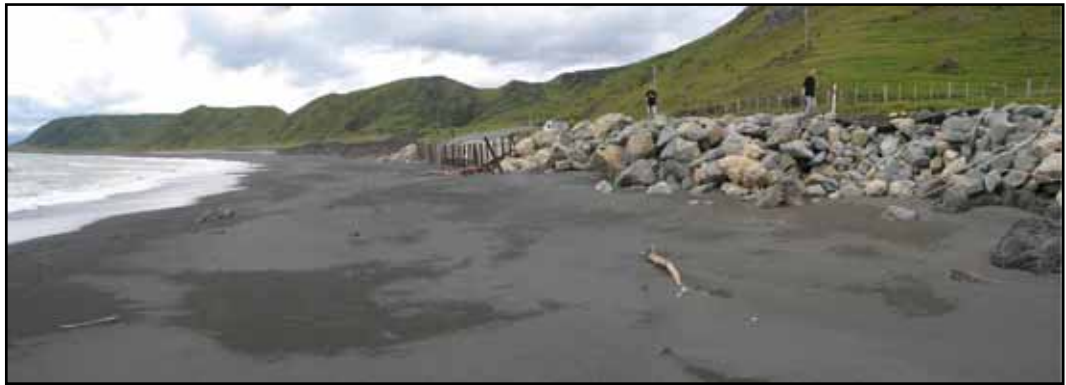
Figure 5: Existing erosion control measures to be replaced as "priority 1" works

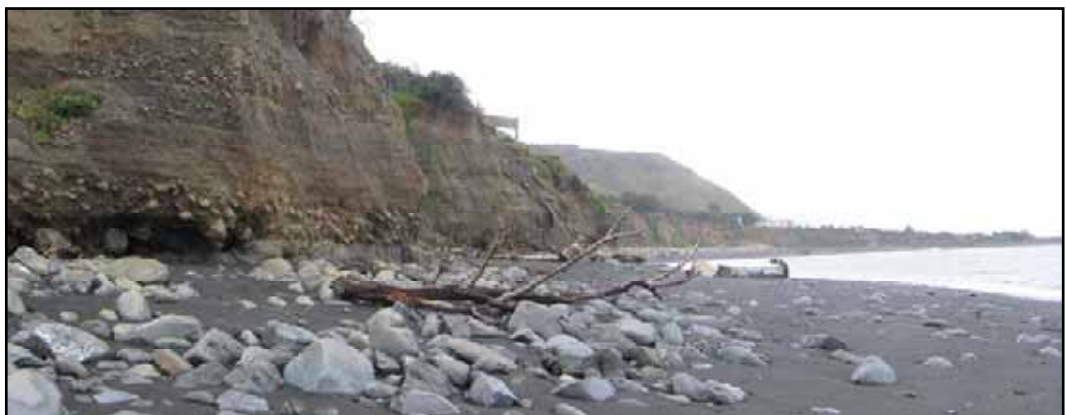
Figure 6: Taller erosion scarp profiles around the settlement of Whatarangi

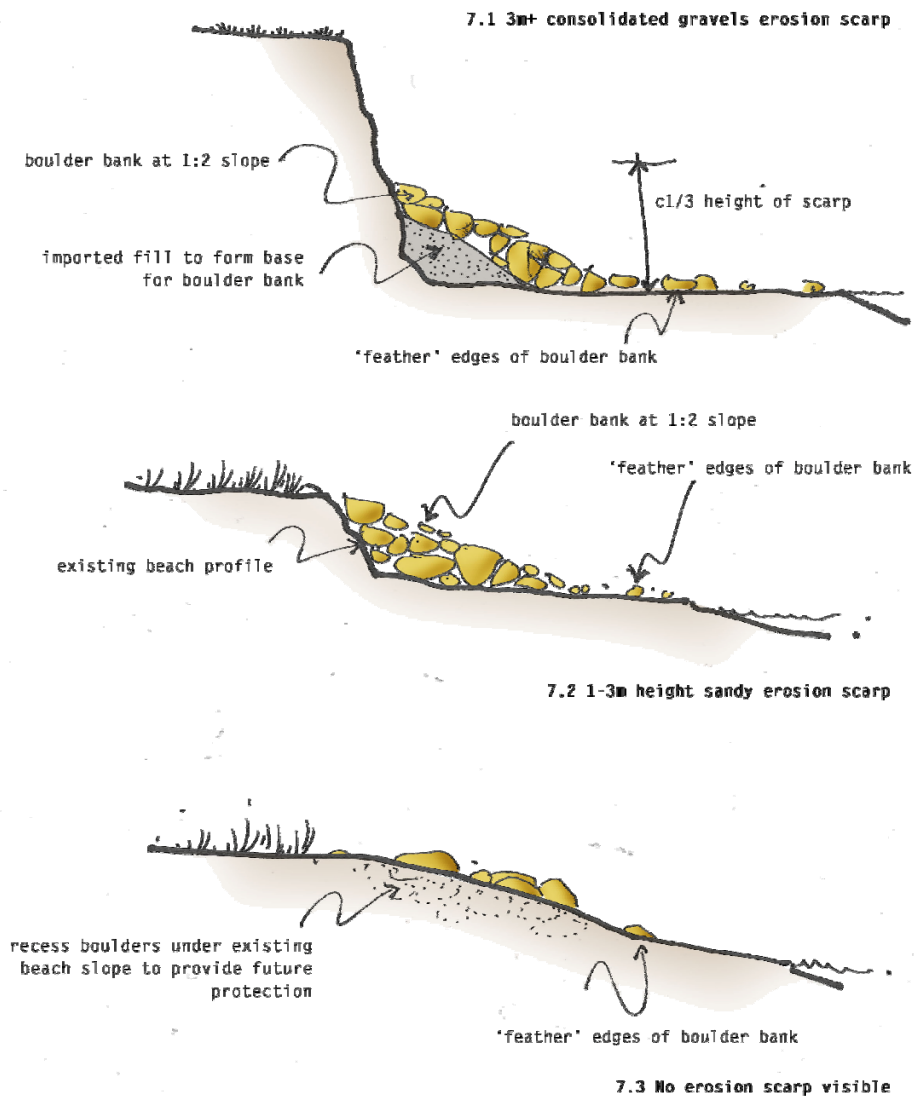
Figure 7 (overleaf) shows a summary of suggested profiles for the boulder beaches under each of these scenarios.

Figure 7: Suggested boulder beach construction for differing foredune profiles

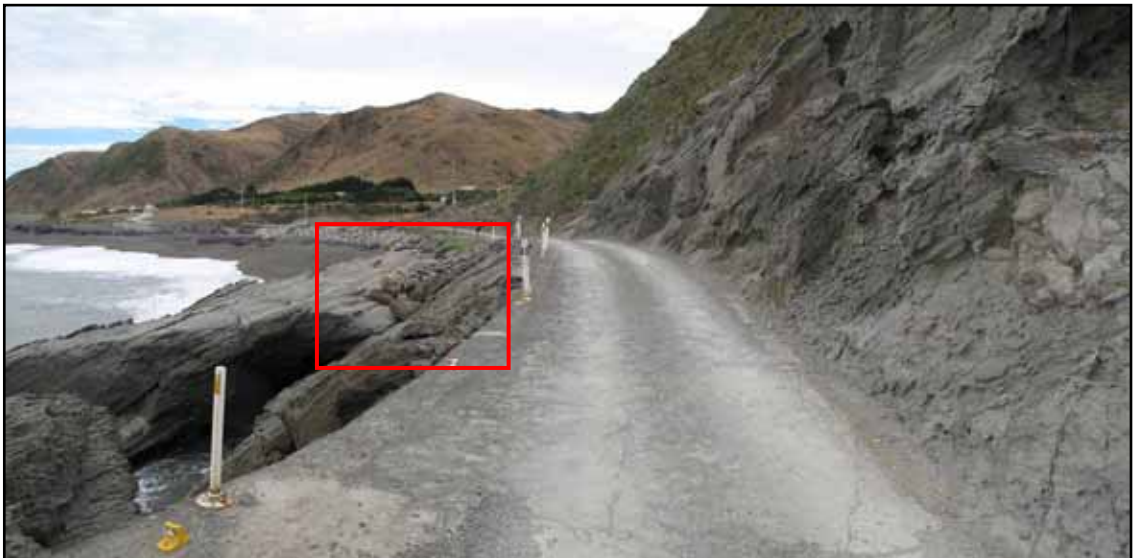
Figure 10: Section of road along the base of Kupe's Sail, with existing 'boulder beaches' highlighted by the red box.

It is in fact the steepness and upthrust nature of the exposed bedrock in this formation that increases its sensitivity to any proposed erosion control works. The natural slope of the bedrock here is such that any loose stones fall straight into the ocean, and rarely collect on the face of the slope. For this reason, any proposal to place a 'boulder beach' along the flat ledges of the formation would not only stand out immediately as being artificial, but in doing so would also detract from the appreciation of the natural processes that formed the landscape. Results of this can already be seen at the western edge of the formation, where a thin line of rocks have been placed on top of a large bedrock sheet (Figure 10), appearing an artificial and somewhat 'ad-hoc' remedy to potential erosion.

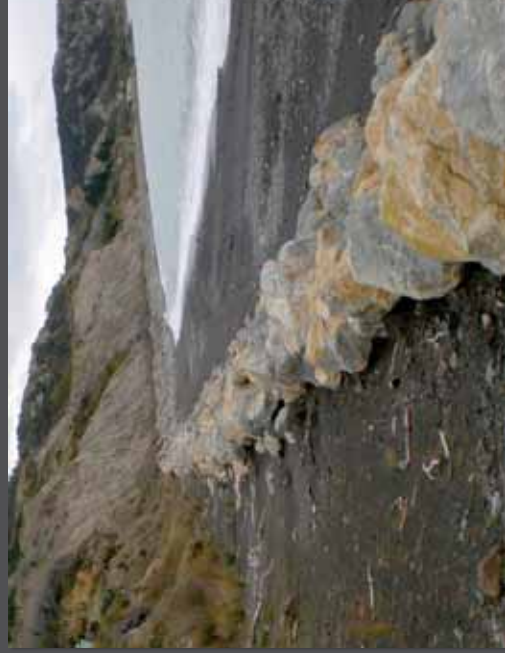
Existing boulder beach along Cape Palliser Road
