Hutt Estuary

Intertidal Macroalgal Monitoring 2012/13

Prepared for Greater Wellington Regional Council March 2013

Hutt River Estuary Intertidal Macroalgal Monitoring 2012/13

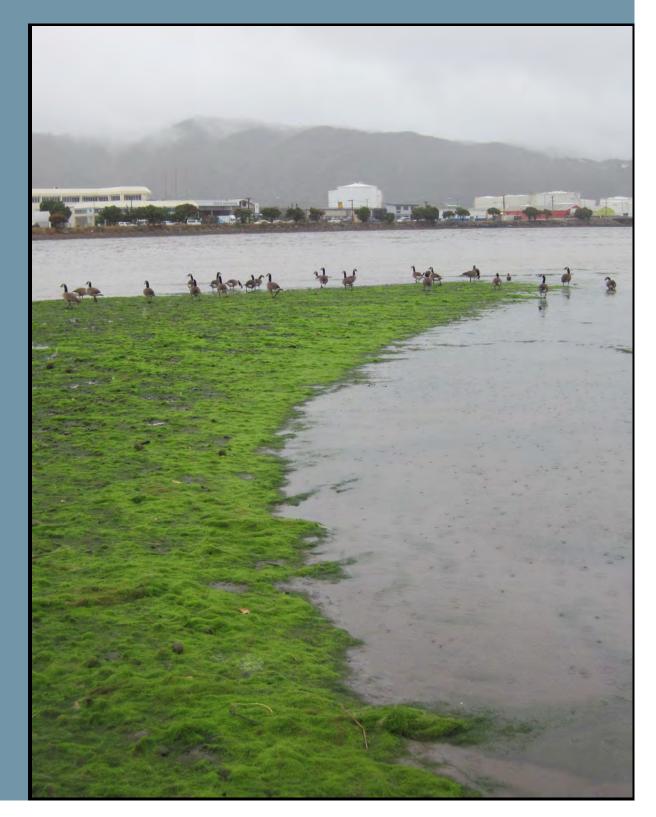
Cover Photo: Ulva intestinalis growing at the mouth of Te Mome Stream, Hutt River Estuary.

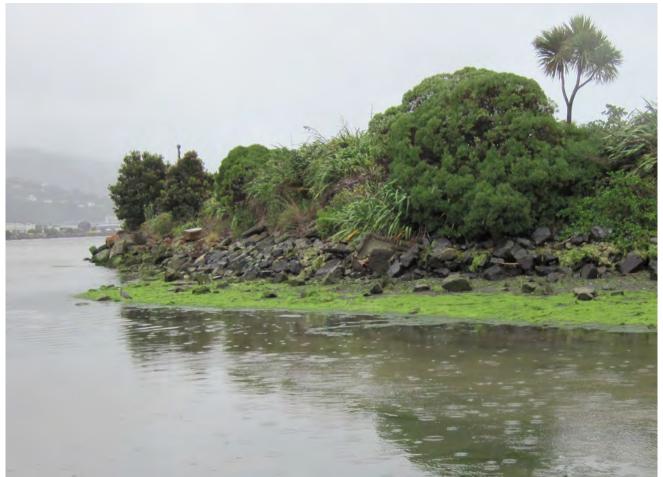
Extensive growths of Ulva intestinalis along the intertidal margins of Hutt River Estuary.

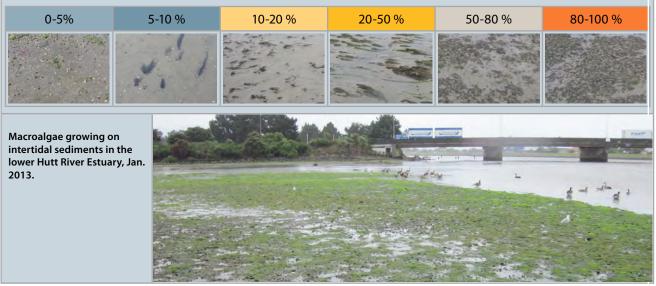
Figure 1. Visual rating scale for percentage cover estimates of macroalgae.

When present, macroalgae was mapped spatially using a 7 category percent cover rating scale (see Figure 1) to describe density.

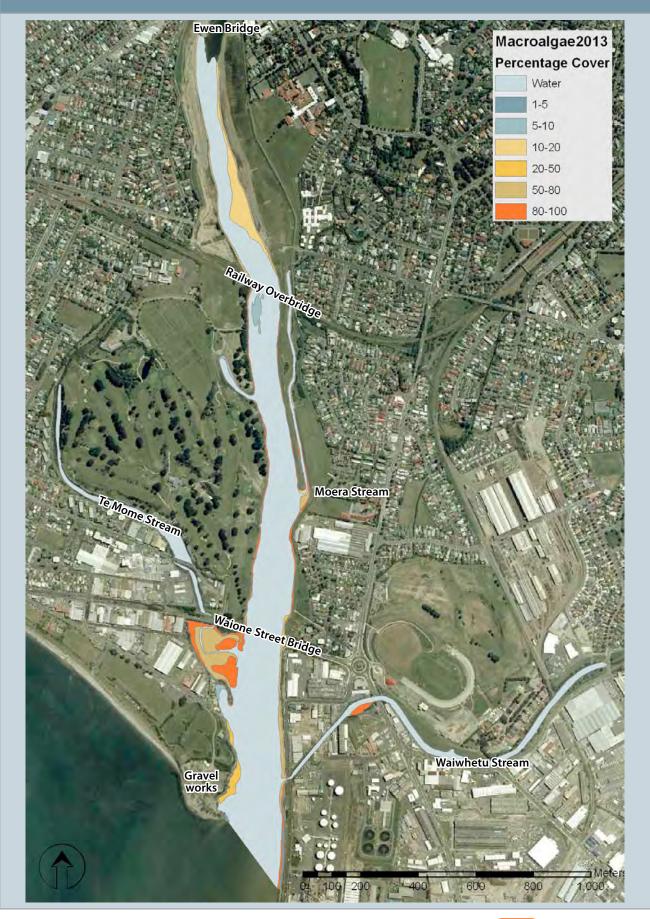
FIGURE 2. MAP OF INTERTIDAL MACROALGAL COVER - HUTT RIVER ESTUARY, JAN. 2013

Figure 2 and Table 1 summarise the results of intertidal macroalgal mapping within Hutt River Estuary. As the highly modified estuary is confined within extensive floodbanks, the intertidal area is restricted to narrow bands along steep rip-rap rock walls and small areas of mudflat habitat present at the mouths of the Te Mome and Moera Streams. Ulva intestinalis is by far the most dominant species and is continuing to grow on almost every part of the intertidal habitat, with an extensive cover extending from the railway overbridge to the Hutt River mouth. Similar conditions are present throughout the linked Waiwhetu Estuary that has its mouth in the lower reaches of the Hutt River. Gracilaria and the green alga Ulva lactuca (sea lettuce) were present but much less conspicuous than Ulva intestinalis and confined largely to the lower intertidal reaches and in subtidal areas near the Hutt River mouth.

Macroalgal condition ratings were revised in 2013 and results from 2010-2013 have been reassessed and presented in Table 2. The 2013 Macroalgae Coefficient (MC) for low density (<50%) cover in the estuary was 4.2, a condition rating of "moderate", and the percentage of the estuary with a high density (>50% cover) macroalgal cover (66%) a condition rating of "very high". This reflects increasing low density cover from 2010 - see Table 2, Stevens and Robertson 2010, 2011 2012), and the extensive and increased cover of dense macroalgae in the lower estuary, mostly below the Waione Street bridge, and on the relatively sheltered intertidal flats near the Te Mome stream mouth. Here, 0.3-0.5m long growths of Ulva intestinalis were common.

Overall, macroalgae is present over the vast majority of the intertidal area within Hutt River Estuary - 8.3ha (97.7%) with greater than 5% cover. Despite the high cover, nuisance conditions (e.g. rotting macroalgae and poorly oxygenated and sulphide rich sediments) were present in only a relatively few intertidal areas, and in subtidal areas near the mouth which is currently muddy, poorly oxygenated, and sulphide rich.

The marked increase in macroalgal growth evident since 2010 means the potential for nuisance conditions and associated adverse impacts in the lower estuary has increased considerably over the past three years. In particular, the estuary is likely to be susceptible to rapid degradation under low flows and in areas where fine sediments are regularly smothered by macroalgal growths.
