**Title:** Contaminants in Te Awarua-o-Porirua Whaitua

**Purpose:** To provide information on contaminants entering Porirua Harbour from the surrounding catchment: sources and transport of, main contaminants, and where they end up.

**Author:** Environmental Science Department, GWRC

**Date:** August 2015

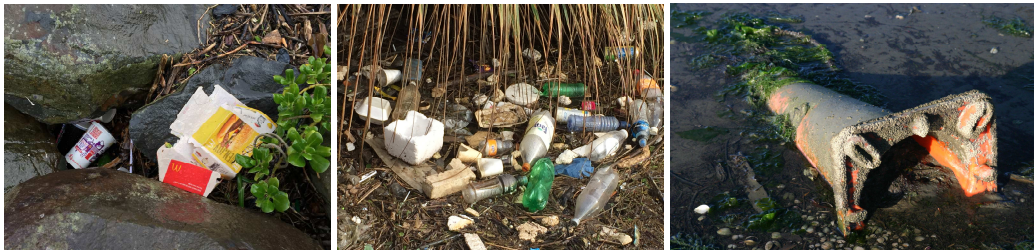
Litter was considered the biggest threat in the whaitua by community in a recent community environmental perception survey commissioned by PCC (Key Research 2014). Litter ranges from takeaway containers and plastic bottles to road cones and vehicle tyres (see below). It is the most visible of the contaminants and can impact/affect the animals, recreational use and ecology of the area.
