Te Awarua-o-Porirua Harbour monitoring

Te Awarua-o-Porirua Harbour is located 21 km north of Wellington City and comprises two inlets; Onepoto, which extends from Mana to the shoreline of Porirua City and Pāuatahanui, which stretches eastwards from the Paremata Bridge towards the Pāuatahanui Wildlife Reserve. The Harbour was originally named Pari-ā-Rua, which translates to “twin flowings of the tide”. Entrances to both inlets provide a calm and accessible area for recreational use, while the head of Pāuatahanui Inlet is home to a world-class wetland reserve that is being threatened by sea level rise.

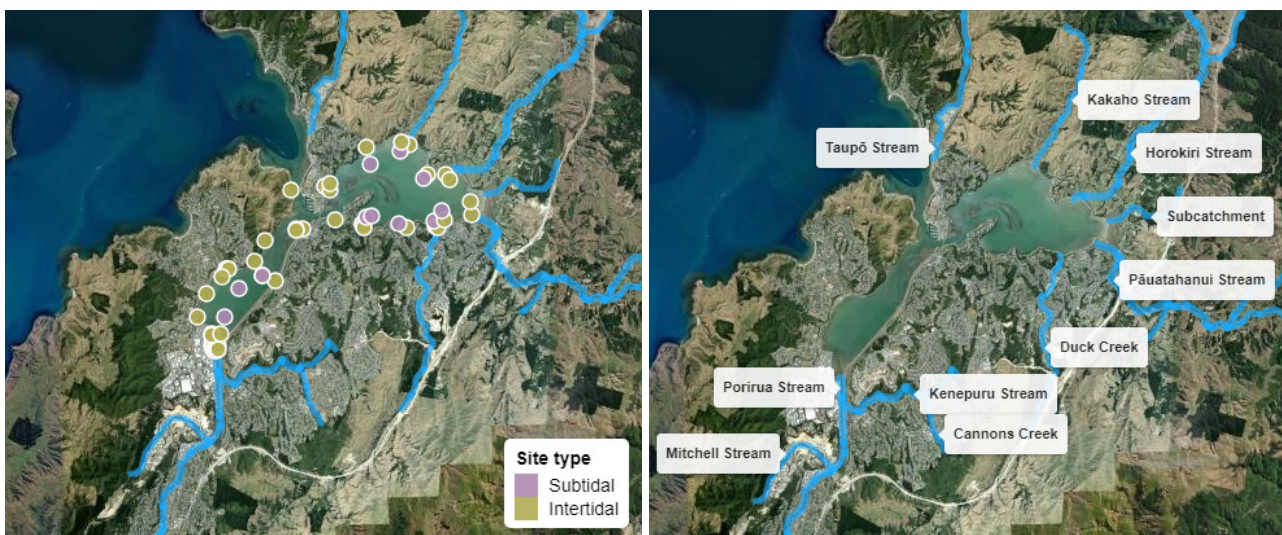
Figure 1: Te Awarua-o-Porirua Harbour monitoring sites and the main stream/creek inputs flowing into the harbour. Note that sites and indicators vary across the sampling period.

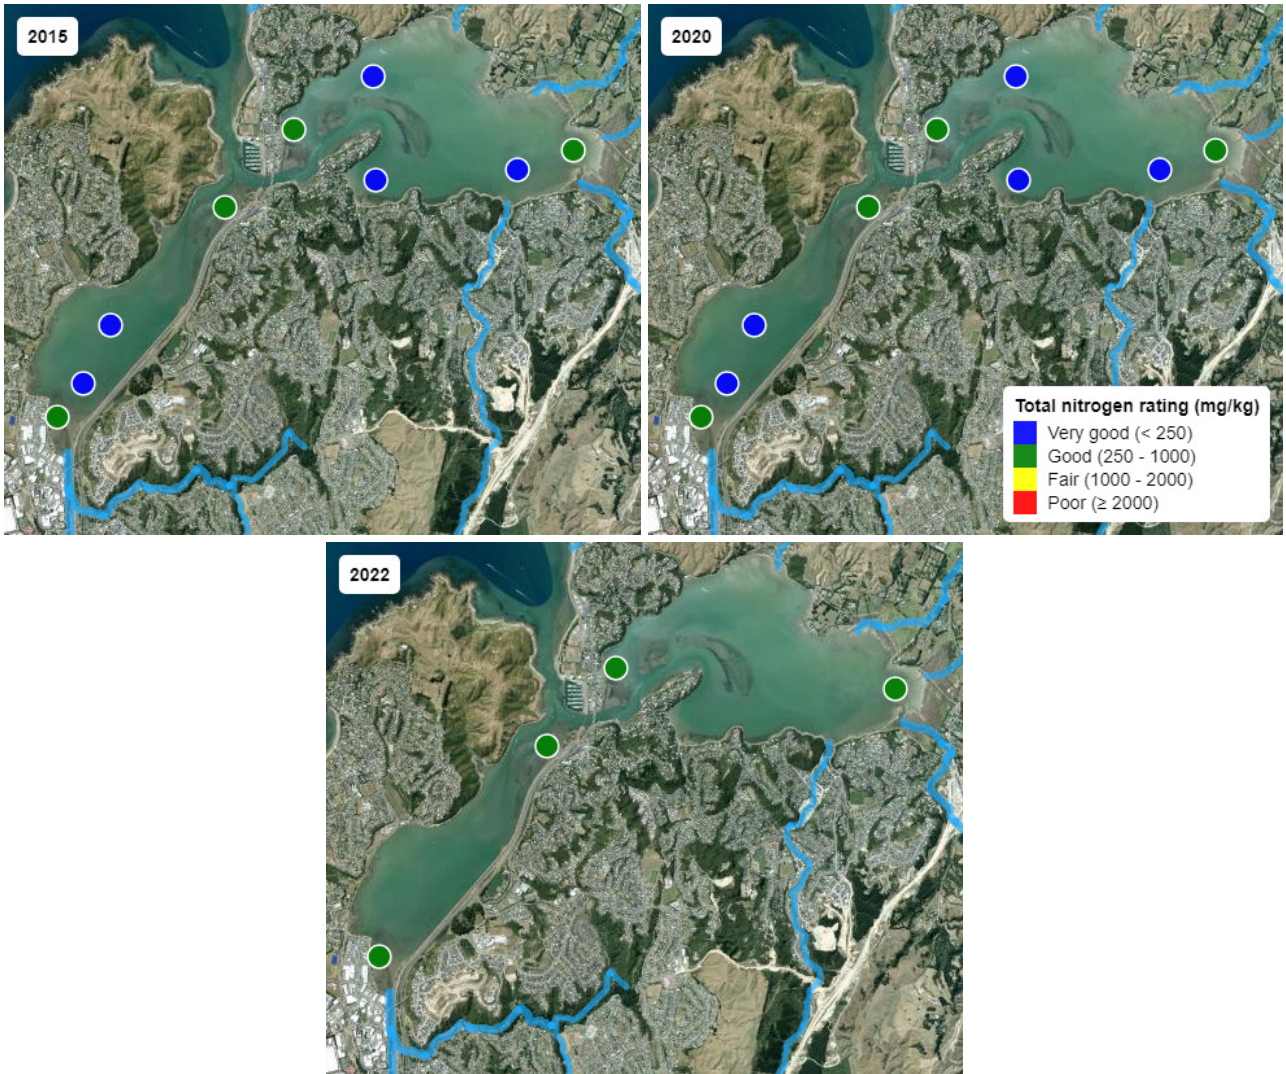
Nitrogen is a key nutrient for plant and algae growth in estuarine and marine environments. Total nitrogen in sediments is an indicator of their trophic status and potential for algal blooms or other symptoms of excessive enrichment. Values are rated against thresholds derived from the New Zealand Estuarine Trophic Index (ETI). See [Cummings et al. 2022](#) and [Forrest et al. 2022](#) for technical methods, data tables, and further information

Figure 25: Total nitrogen (mg/kg) ratings for 2008, 2009, and 2010.

Figure 26: Total nitrogen (mg/kg) ratings for 2015, 2020, and 2022.
